## City of Alexandria Storm Sewer Capacity Analysis (CASSCA)

### Backlick Run Condition Assessment

**PREPARED FOR:** City of Alexandria, CH2M Hill  
**PREPARED BY:** Michael Baker Jr., Inc.  
**DATE:** October 9, 2013 (Revised May 26, 2015)

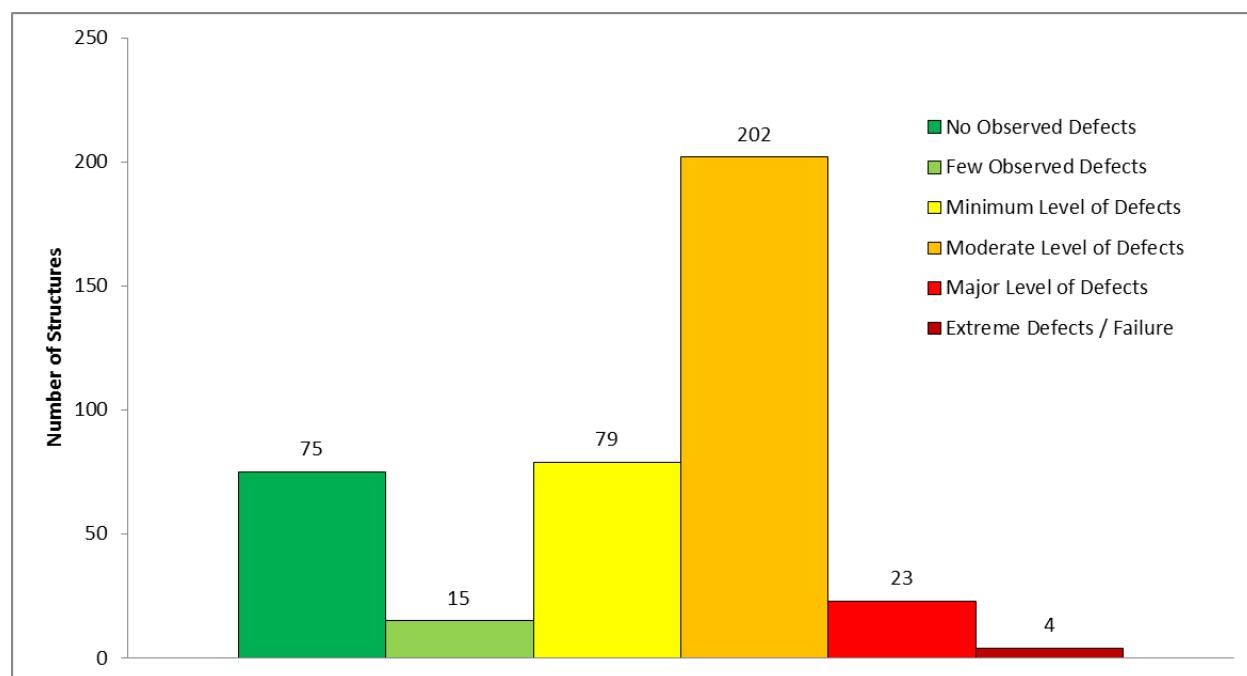
As part of this inspection task, 398 storm structures were inspected in the Backlick Run watershed. Figure 1 shows the number of structures identified within each defect category identified in the previous section. Figure 2 is provided to show the geographic location of each structure within the Backlick Run watershed, color coded to its defect category. The average condition score of the 398 storm structures was 38 (Minimum). Twenty-seven (27) structures had scores of 61 or higher, placing them in either major or extreme categories. About 23% of the structures showed few to no defects, while approximately 70% of the structures ranked in the minimum to moderate defect categories.

**Figure 1. Structure Inspection Summary.**

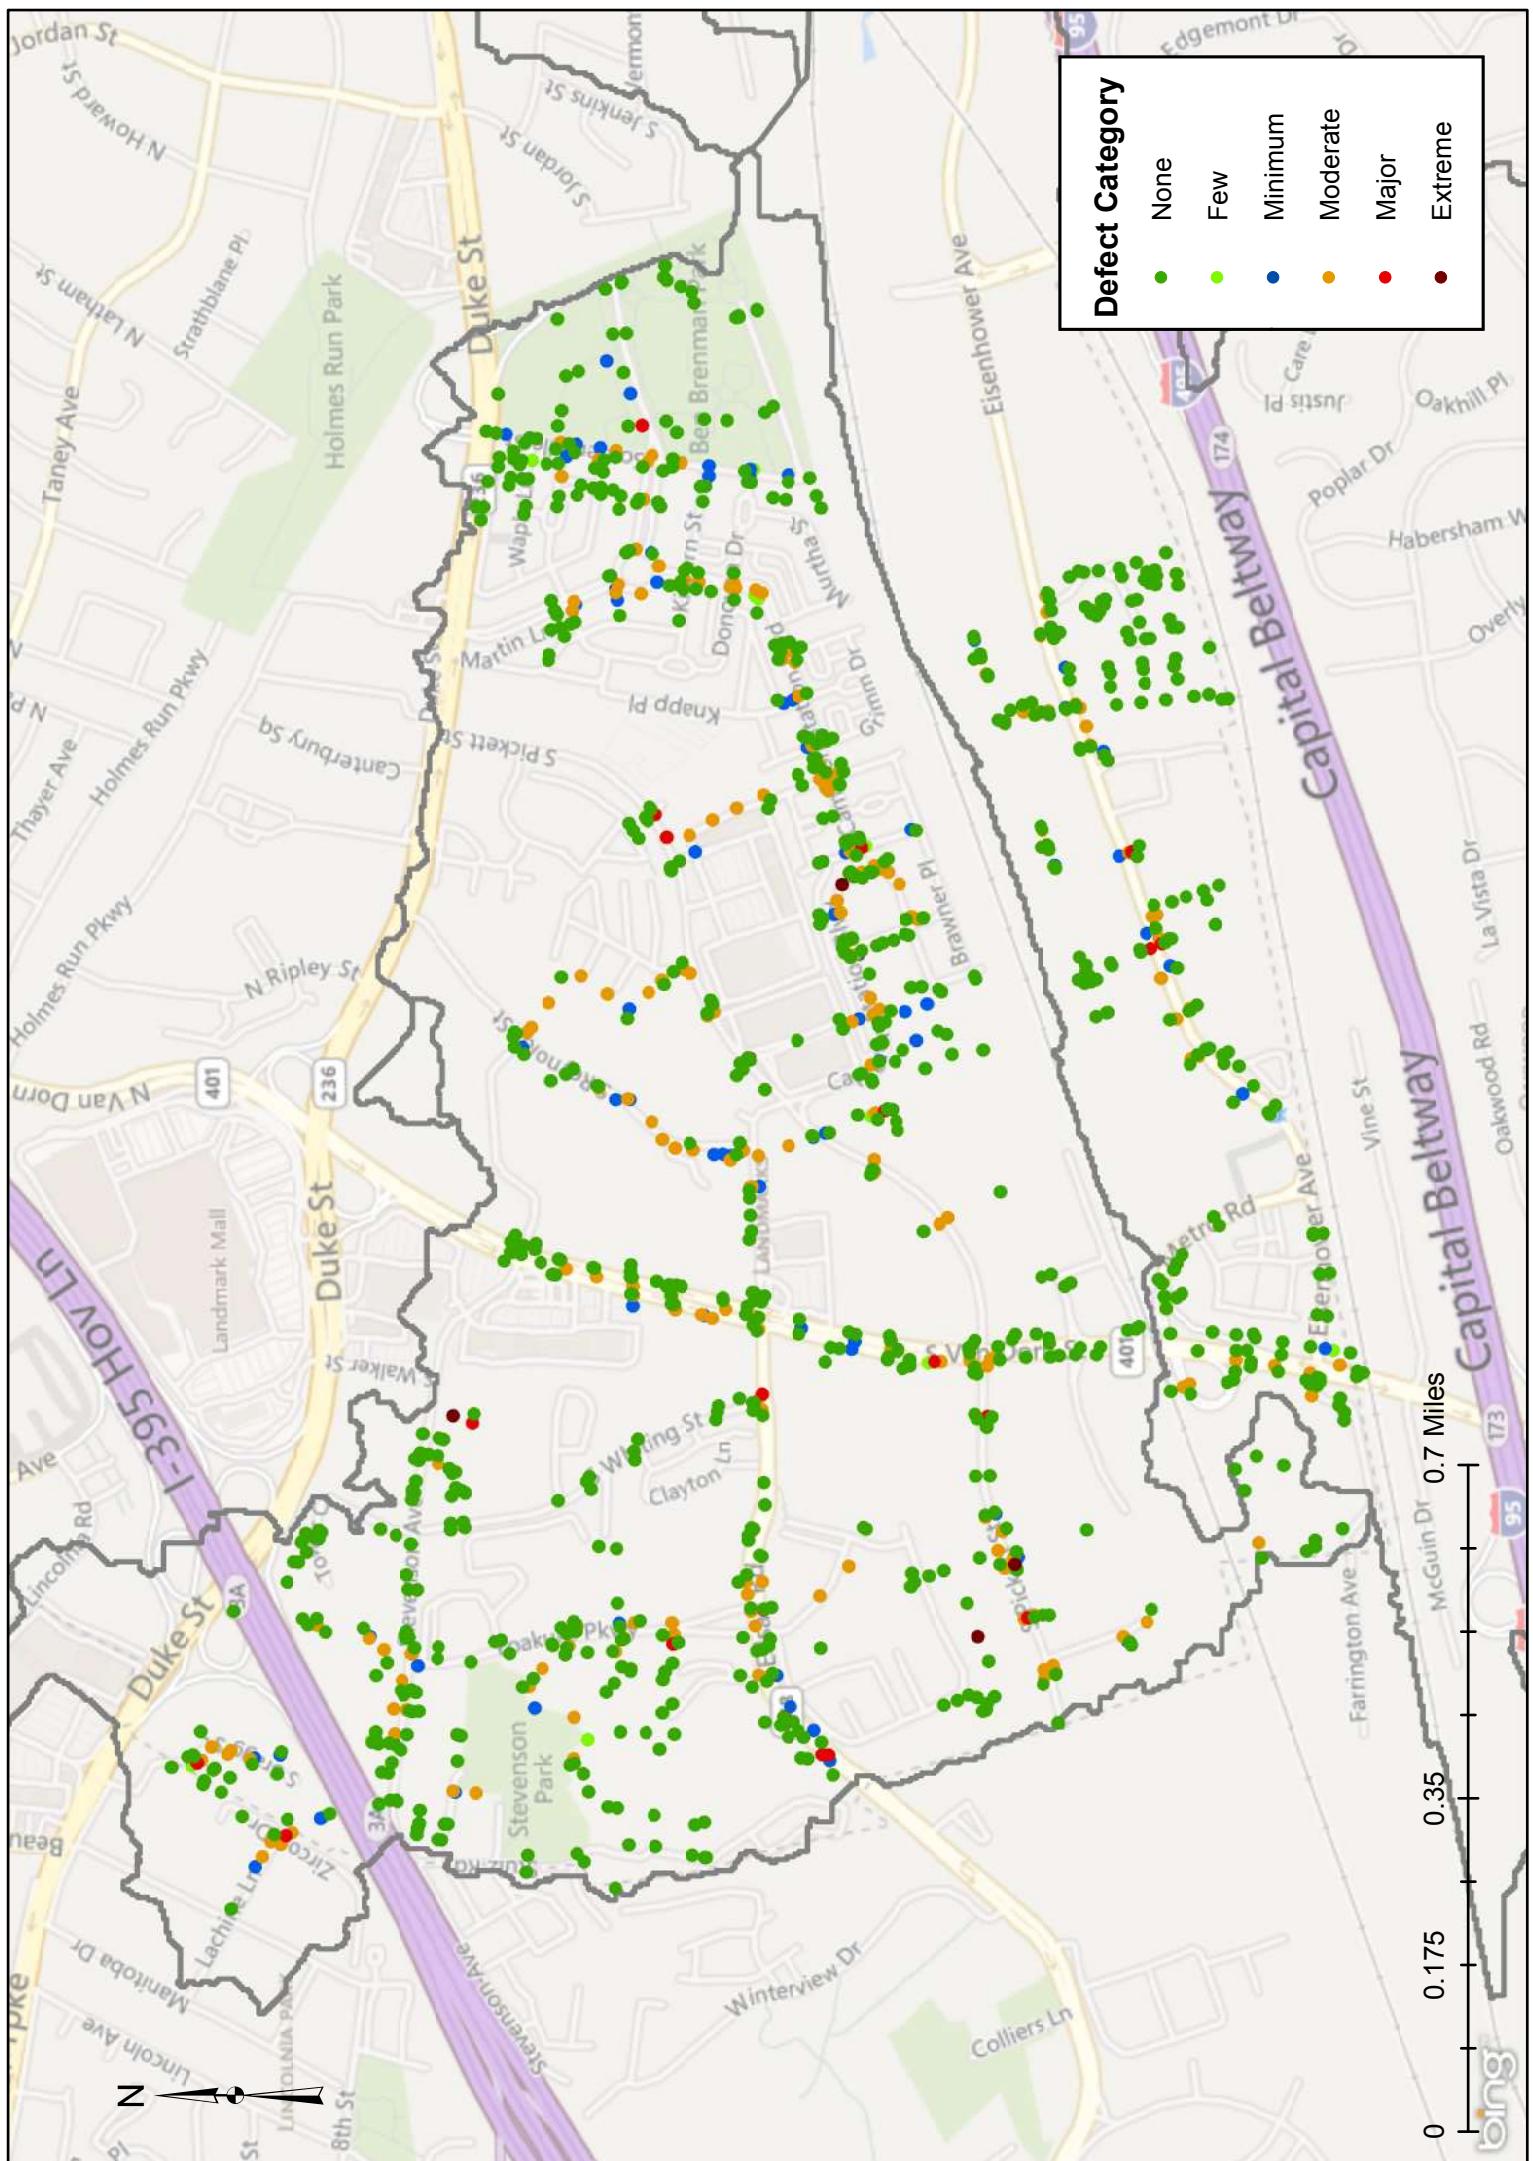
Figure 2. Overall Condition of Storm Structures (Color coded by Severity of Defects).

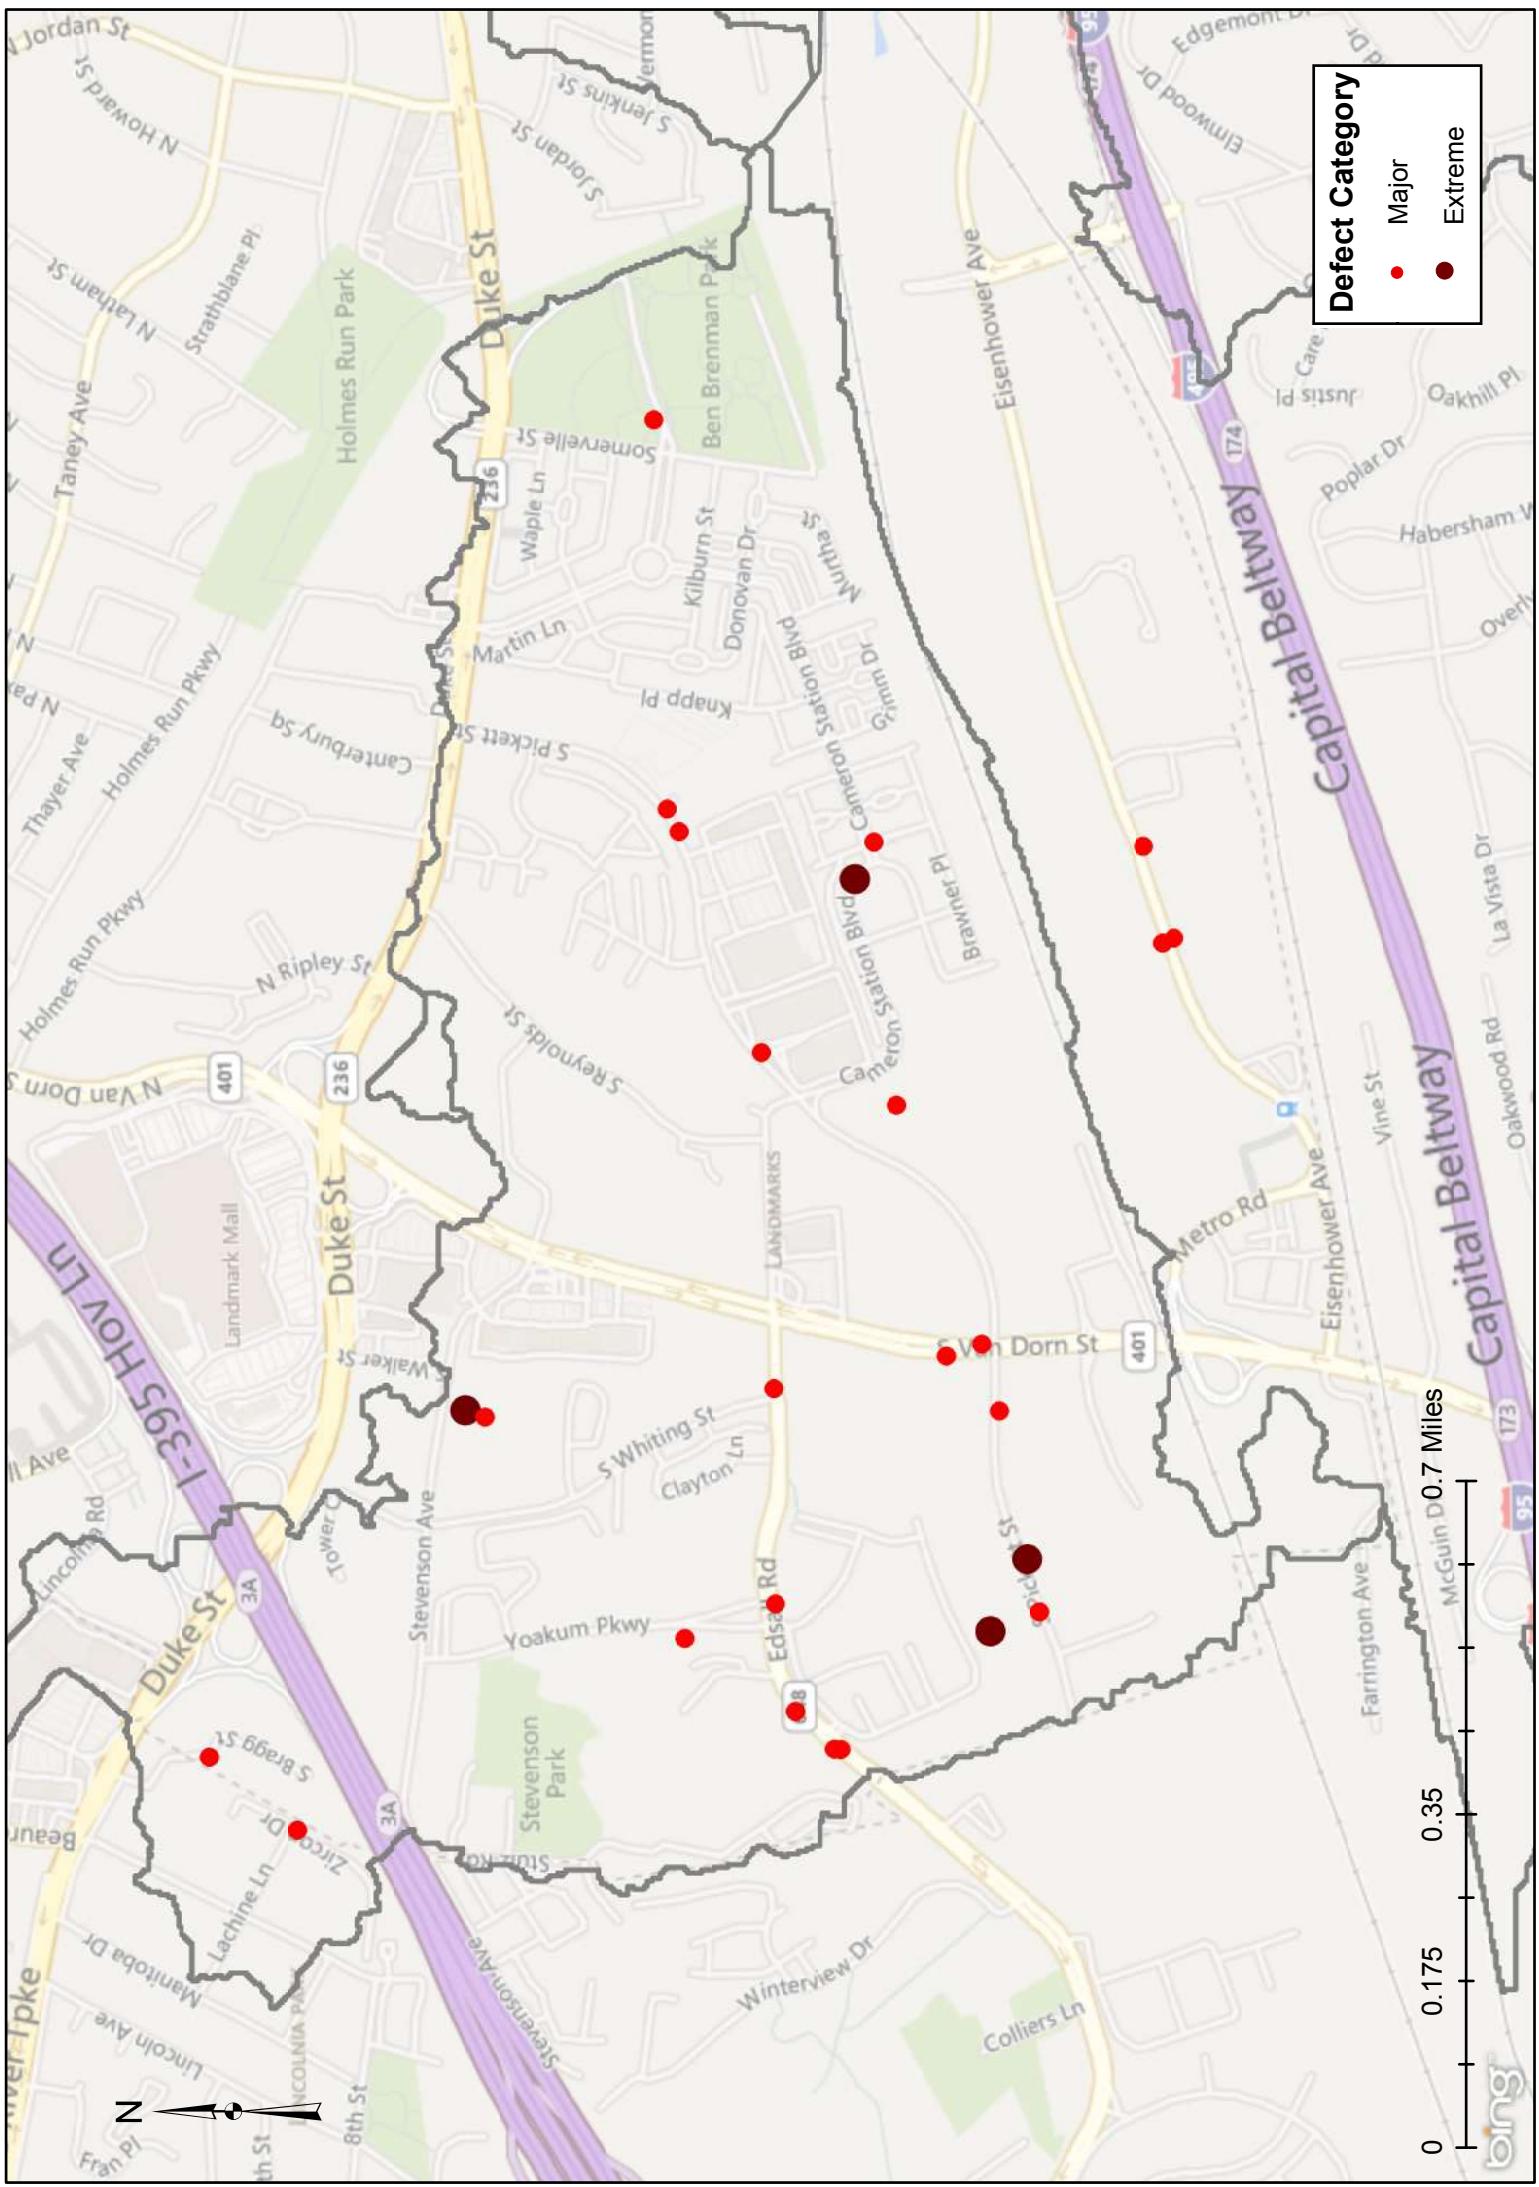
Figure 3 displays the location of the structures classified with major and extreme damage only. In the Backlick Run watershed, structures with high defect scores are distributed near Stevenson Avenue, S Pickett Street, and Cameron Station Boulevard. The inspection results of the structures were broken down by structure component for further detailed condition assessment. Table 2 lists the number of observed defects by component and severity. Note that the table shows a count of the number of defects found in each component and their respective severity across all structures, not the number of inspections performed. Multiple defects may be found in a single component of a structure.

**Figure 3. Location of Storm Structures in the "Major" and "Extreme" Categories (Color coded by Severity of Defects).**

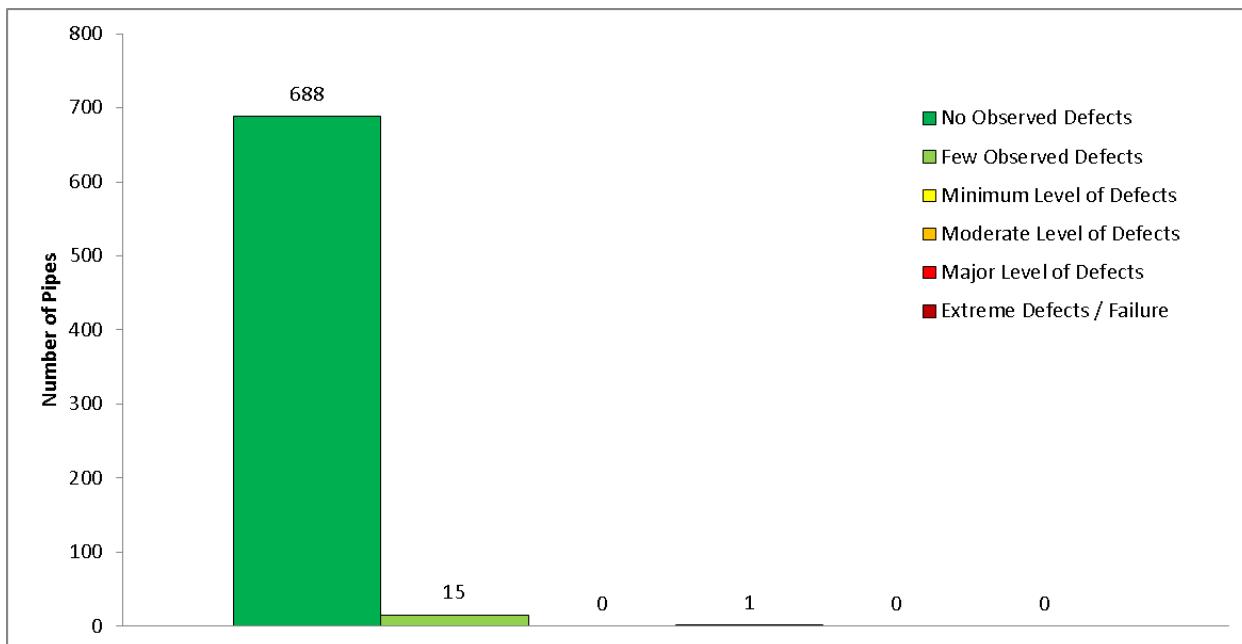
In total, 704 storm sewer pipes were inspected in the Backlick Run watershed. Figure 11 shows the number of pipe segments within each defect category. Figure 12 shows a map of the location of each inspected pipeline, color coded by the defect categories identified previously in the memorandum. The average condition score of the 704 storm pipe segments inspected within the Backlick Run watershed was 0.2 (Few to No defects). Inspection results in Backlick Run watershed showed that the pipe segments were observed to be in generally excellent condition, with no defect observed in 98% of the pipes.

Figure 11. Pipe Lamping Inspection Summary.

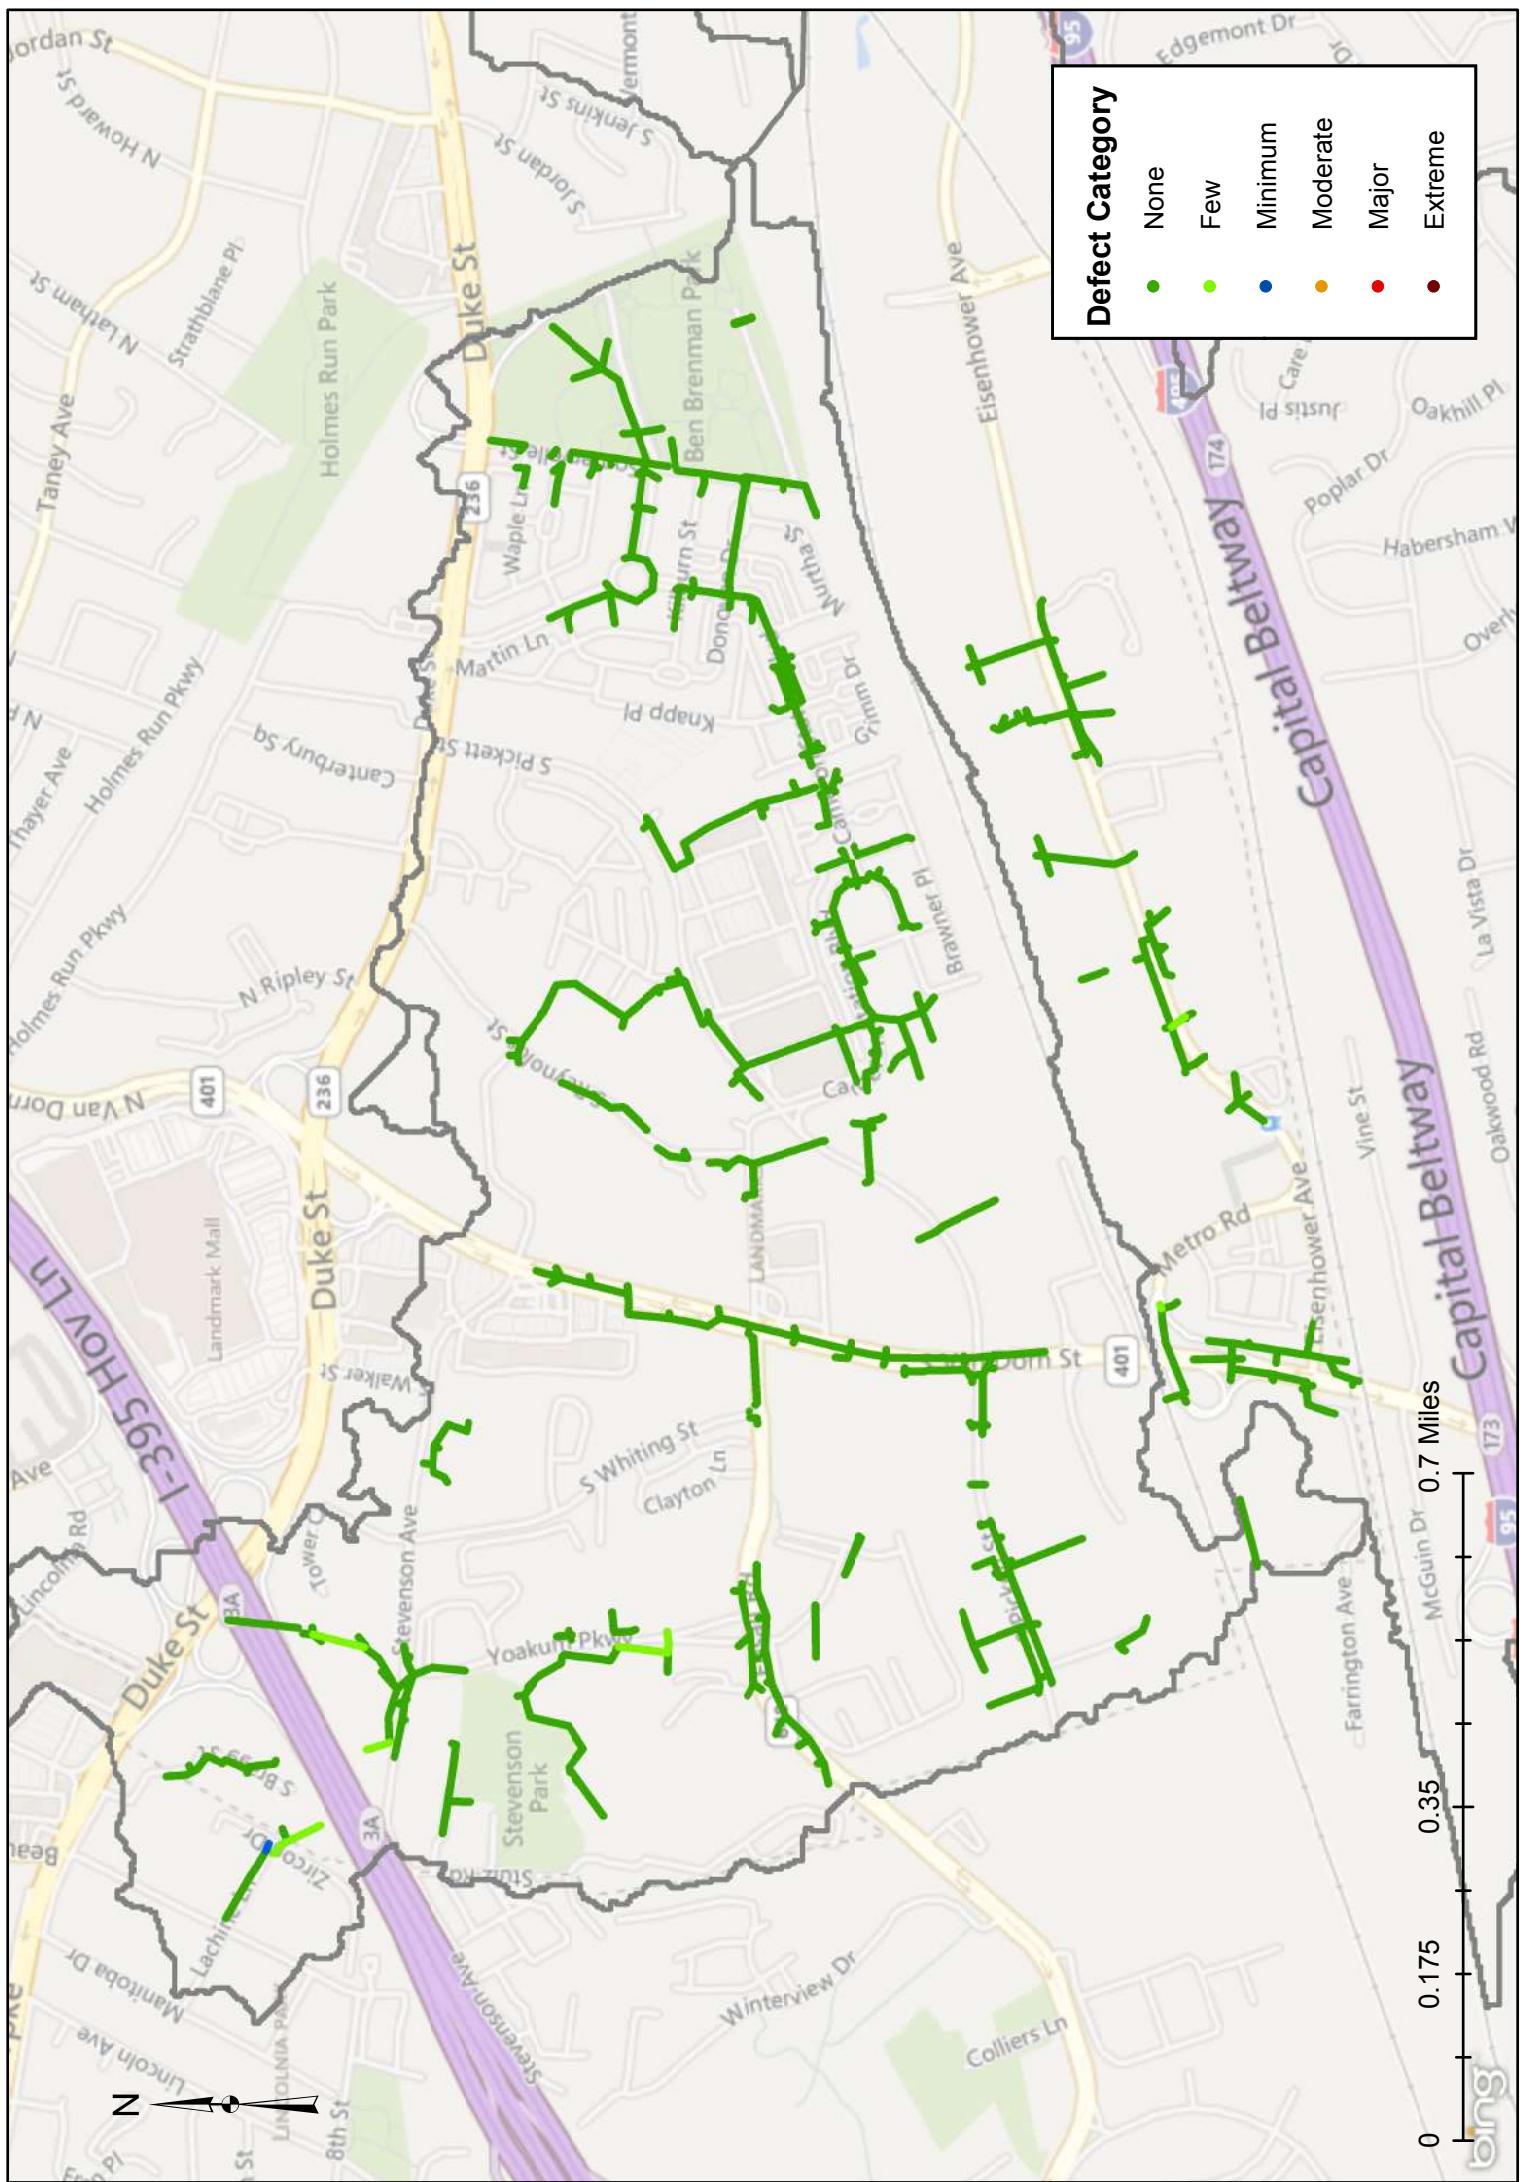
Figure 12. Overall Condition of Storm Pipelines (Color coded by Severity of Defects).
